Manhole Inspection Summary

Manhole # S19G__023MH

Insp Date: **10/4/07 12:29 PM**

Location Address: **2111 FAIRMOUNT-BALTIMORE**

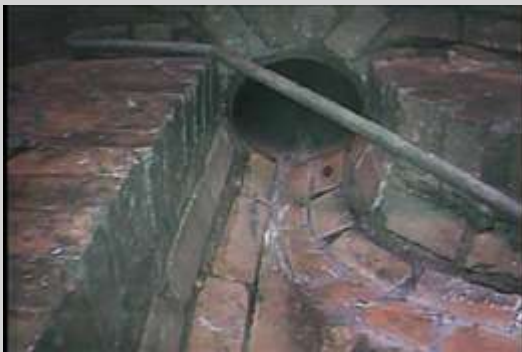
12 O'Clock Outflow

8 in. Circular Gravity Sewer
Pipe Out @ 12 O'Clock

Pipe Height: **7.2** (in.) Rod and Bar (Angled)
Pipe Material: **Clay** ☐ Pipe Lined
Invert Depth: **9.43** (ft.) Flow Characteristics: **Slow**
Deposits: ☒ None ☐ Mud ☐ Sludge ☐ Debris ☐ Grease
Silt Depth: (in.) Deposits Extent:
Infiltration: **None** Pipe Seal Cond: **Sound**

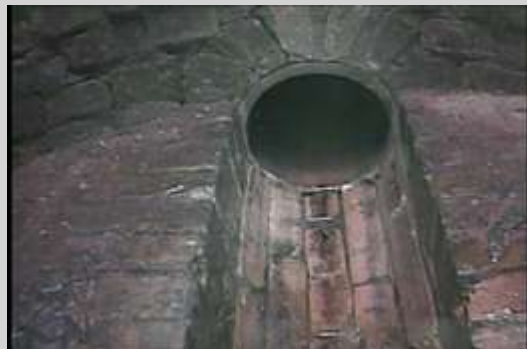
6 O'Clock Inflow

8 in. Circular Gravity Sewer
Pipe In @ 6 O'Clock

Pipe Height: **8.4** (in.) Rod and Bar (Angled)

Pipe Material: **Clay** ☐ Pipe Lined

Infiltration: **None**
